Gardner Denver Nash Failure Analysis

Erosion Failure

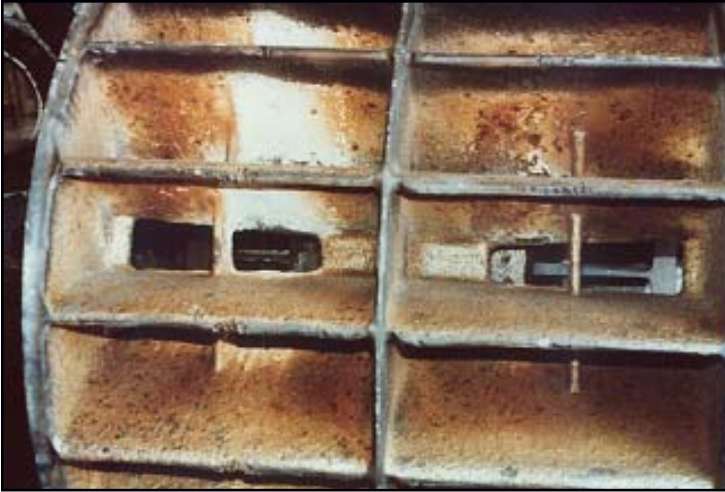
Erosion damage to rotor

Failure due to erosion is evident in various areas of the pump. Wear could cause extensive damage if it goes undetected. Sources of erosion are pump inlet and seal water supplies.

Seal Water Supply

- Solids in seal water
- Lobe purges plugged

Pump Inlet

- Solids/abrasives in inlet stream
- Pre-separator not working
- Lobe purges plugged

Seal Water Supply

- Check water for suspended solids
- Check lobe purge piping for plugged lines

Pump Inlet

- Check inlet stream for suspended solids
- Check pre-separator water removal pump
- Check lobe purge piping for plugged lines
- Perform periodic borescope inspections to monitor wear
