Gardner Denver Nash Failure Analysis

Cavitated Rotor

Failure Due to Cavitation

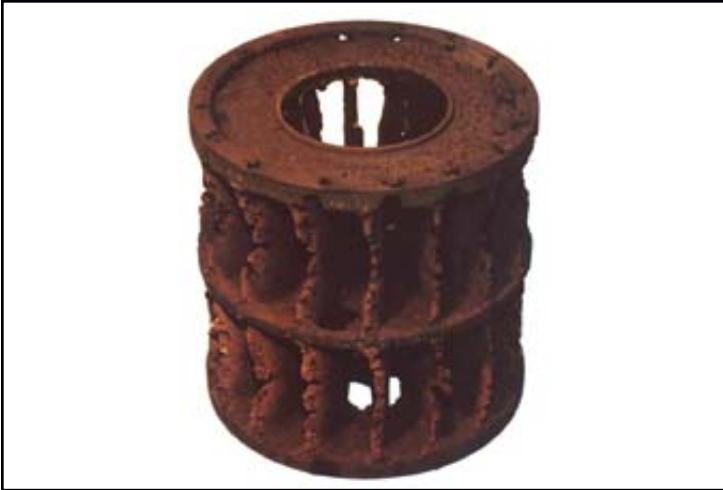
Cavitation is caused by the presence of gas bubbles under high pressure being suddenly subjected to a low pressure. This causes the bubbles to burst (implode) and release energy to the metal surface, which causes the fracture of small, minute pieces of metal from the base casting.

Seal Water/Liquid Compressant

- Incorrect seal water (liquid compressant) rates
- Operation of liquid compressant above its vapor pressure
- liquid compressant saturated with minute gas bubbles under pressure

Blocked Discharges

- Discharge port, pump outlet or drain blocked

Improper Clearances

- Clearance wide on pumps operating at high vacuum levels

Improper Working Pressure

- Working beyond maximum operating pressure (vacuum or compressor)

Seal Water/Liquid Compressant

- Ensure proper seal water/compressant rate
- Lower vacuum
- Change liquid compressant
- Remove bubbles from liquid compressant

Blocked Discharges

- Unblock all ports, outlets and drains

Improper Clearances

- Ensure proper clearance is maintained

Improper Working Pressure

- Lower operating pressure
